THE KERAUGA CAVE AND LÆKJARBOTNAVEITA IN SOUTH ICELAND – GROUNDWATER SAFETY AND HYDROGEOLOGY

Abstract. This research looks at water protection of Lækjarbotnar and Kerauga springs in South Iceland. Discharge measurements show that Minnivalla- and Tjarnalækur streams lose 350 and 1350 l/s respectively into the ground. The equivalent amount springs to surface along the edge of the Þjórsá Lava and Búði Glacial Moraine in a few springs. Tracer tests indicate that lost surface water of Minnivallalækur transits partly along a fracture to Kerauga in 65 days and to Lækjarbotnar in 125 days through the Þjórsá Lava over a similar distance of about 5 km. Hence the lost surface water of Tjarnalækur in the east is unlikely to travel past this drainage divide west of the fracture to Lækjarbotnar but more likely to drain into Ytri-Rangá. Thus a proposed poultry farm in that area proposes minimum direct risk to water safety of Lækjarbotnar. As a result of this connection Kerauga is not a safe source of drinking water. The aquifer is considered unconfined, heterogeneous and anisotropic. It is recommended to define inner and outer protection zones for Lækjarbotnar further north and to springs of Min

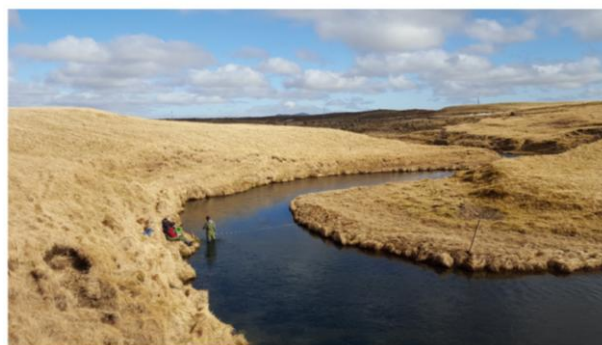
Fig. 4. Discharge measurements in the river Bjallalækur. The Búði Glacial Moraine can be seen in the distance.

In order to measure discharge of rivers and creeks, a stream meter with a spinning propeller was used to measure the velocity as further reviewed by Claesson and Collett (2016). The measurements were done over a cross-section in the river where the flow was smooth, steady and even (Fig. 4). Discharge measurements were performed in the following rivers and brooks; Tjarnalækur, Minnivallalækur, Bjallalækur, Kálfhagalækur, Grófarlækur and Tjörvastaðalækur in addition to several spring measurements by estimating surface velocity with a buoyant material for Tvíbytnulækur, Kálfhagalækur, Ytri Rangá and along Tjörvastaðalækur before the confluence of Bjallalækur. The measurements were done in April and May 2016. The electrical conductivity and temperature were measured.

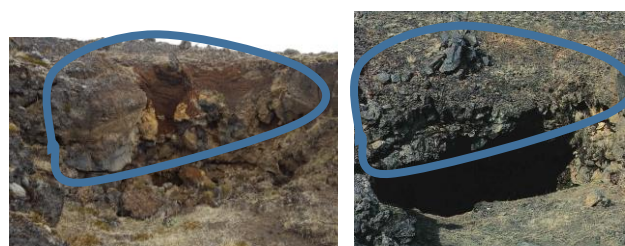
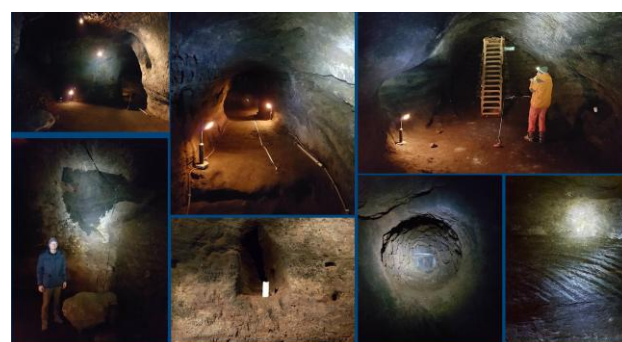
Fig. 5. Top: Kerauga at present (to the left) compared to the entrance in 1990 (to the right) as seen in Hróarsson (1991). Below: Exploration of students of Hellnahellir cave showing effects of oxidation, overall shape of the cave and religious markings (photos from Andrina Janicke).

Relative elevation was surveyed in autumn 2016 around Kerauga and Hellnahellir cave using a laser distance sensor and a elevation laser level to determine relative elevation of survey points. The laser emitter to estimate elevations changes was equipped with a self-leveling. For comparison purposes photographs were taken in Hellnahellir and photographs from previous diving expeditions were scanned and compared (see figs. 1 and 5).

Surveying of Hellnahellir illustrates a level of complexity in the cave with restrictions and chimneys e.g. for light (Figs. 5 and 10).

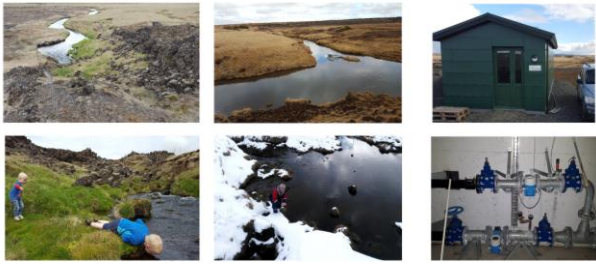
Fig. 7. Tracer sampling sites. From left: Kerauga spring, Kálfhagabotnar spring a tributary to Bjallalækur and tap water at the pumping station at Lækjarbotnar in addition to samples taken in the stream next to the station.

- 1) Several photographs from the diver Pálmi Dungal clearly illustrate a rounded ceiling made of sandstone. From a geological point of view it is difficult to explain the shape of the ceiling to have been naturally formed. Land surveying revealed that the regional sandstone found west and south of the cave is about a meter above the surface of the water in the cave ruling out the possibility it being a lava tunnel in the front. Oxidation of the sandstone has occurred which is typical when in contact with air. When reviewing the geological settings between the cave and the Tjörvastaðalækur stream it is plausible that one is looking at a collapsed area. The tubular spring of Kerauga indicates the water is flowing out of an underground cavern (Fig. 7).

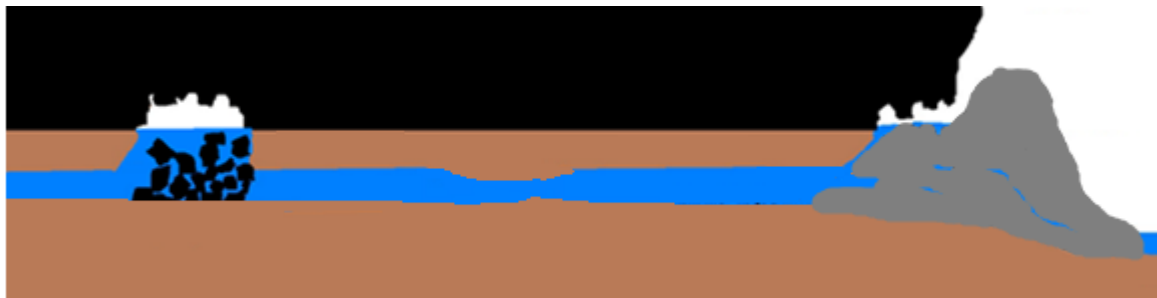
Fig. 11. It is hypothesized that Kerauga cave is a man-made cave based on interpretation of the description given by the divers. Water pressure was at maximum 0.5 bars indicating a 5 m depth from water surface. Tight restriction described in the mouth of Kerauga cave. Then a long tube until a tighter restriction divides the cave into two chambers. Then Pálmi Dungal and Kristinn Einarsson refer to a collapse at the end of the cave which Bernie Chowdhury claims he was able to pass and sit on top of and breathe air inside with a strong current in the rubble. He claims he could see a third chamber which he didn't survey similar to the previous ones. The length of the cave is unknown but thought to be extensive (100–300m).

Taking the above into account it is very likely that the cave is in fact in the alluvial sandstone a few meters below the Þjórsá Lava. From this it is hypothesized that the Kerauga cave is manmade and that the entrance to it is through a collapsed ceiling a few meters inwards from the original entrance (Figs. 11 and 12). The supporting factors are:

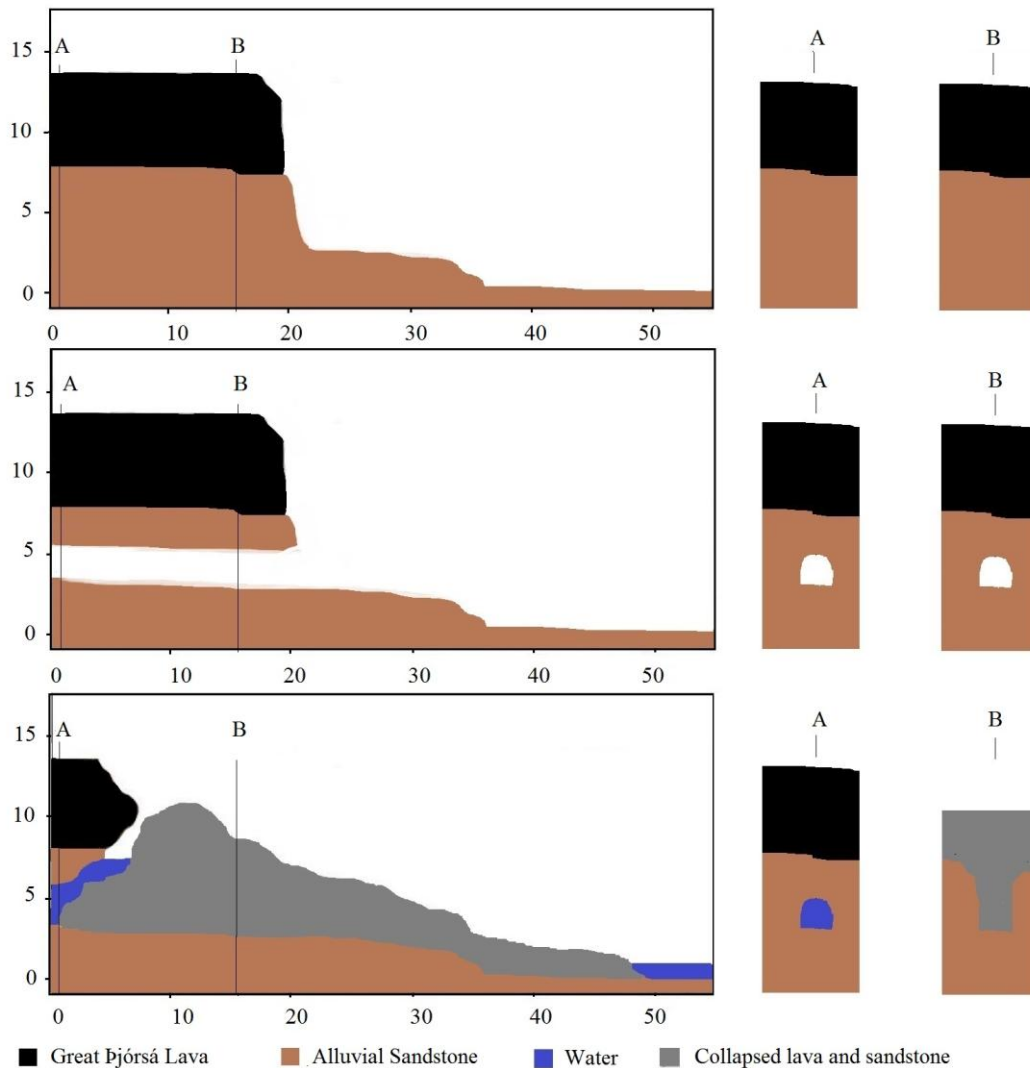
Fig. 12. The Kerauga cave in natural settings (top), after the cave was dug out (middle) and after the entrance caved in (bottom). Land surveying conducted by students in autumn 2016 for scale in terms of relative elevation and distance shown in meters on the graphs. Cross sections estimated.
